ABRASION RESISTANCE OF LININGS IN FILAMENT WOUND COMPOSITE PIPE

Sylvia C. Hall, P.E.
Ameron International Corporation
Engineering Development Center
8627 South Atlantic Avenue
South Gate, CA 90280

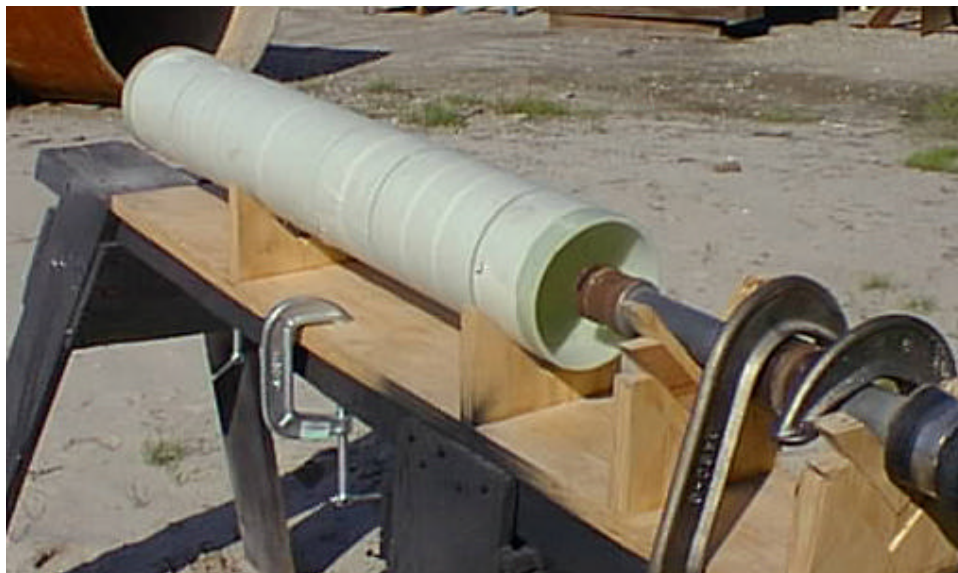
FIGURE 1 - Test setup for sandblasting assembled pipe specimen.

The specimens consisted of one 2-inch (5.1-cm) diameter UHMW PE pipe, one 0.020-inch thick polyurea-lined and one unlined 2-inch (5.1-cm) diameter glass-reinforced epoxy (GRE) pipe, and one 2-inch (5.1-cm) diameter unlined steel pipe. Each pipe specimen was cut into fifteen 2-inch (5.1-cm) long ring sections. The PE pipe rings were weighed to 0.1 gram and the GRE and steel pipe rings were weighed to 0.0001 gram. The thickness of the pipe wall at four selected locations at both ends of each ring was measured using a caliper and averaged to 0.001 inch. The rings were reassembled in the order and position in which they were cut, mounted rigidly and horizontally, and sandblasted axially. The sandblast nozzle was placed flush at the end of the pipe and centered to the bore of the pipe. A number 20 silica sand was used because the average grain size was closest to the 1-mm (0.0004 inch) diameter particles expected in a copper sulfate slurry line. The sand was discharged at about 50 to 60 lbs (22 to 27 kg) per minute at an air pressure of 60 psig (410 kPa). After sandblasting, the weight and wall thickness of each ring were determined as described above. The pipe specimens were sandblasted three times in 10 minute intervals. Figure 1 shows the apparatus and setup.

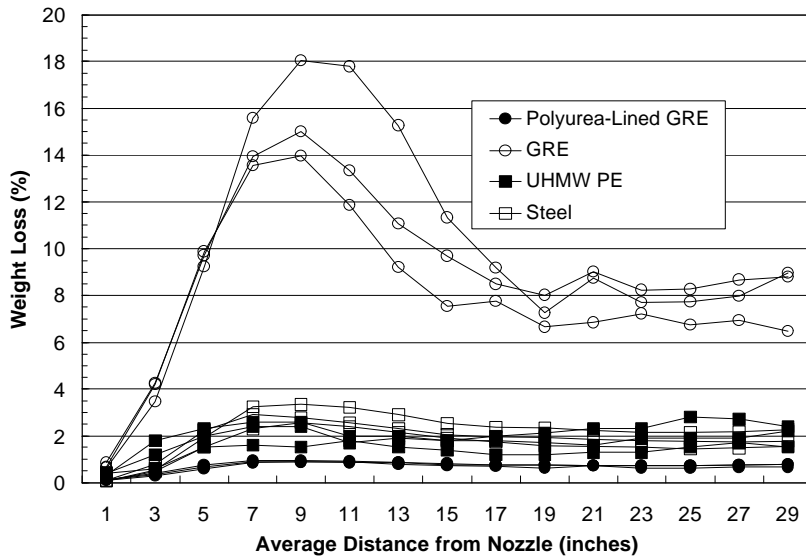
FIGURE 2 - Individual weight loss along the length of the pipe specimens after 10 minutes of sandblasting.

The individual and average percent weight loss and the average loss of wall thickness along the length of the polyurea-lined GRE, unlined GRE, UHMW PE, and steel pipe specimens are shown in Figures 2, 3, and 4, respectively. The conical blast pattern exiting the nozzle expanded radially producing an array of incident angles and particle velocities. The highest wear rates occurred between 6 and 16 inches (15 and 41 cm) down the pipe bore of the 2-inch (5.1-cm) specimens where the majority of the particles contacted the pipe wall initially. The wear rates declined further down the pipe length as a result of the particles bouncing off of the pipe wall, losing velocity, and aligning with the pipe bore.

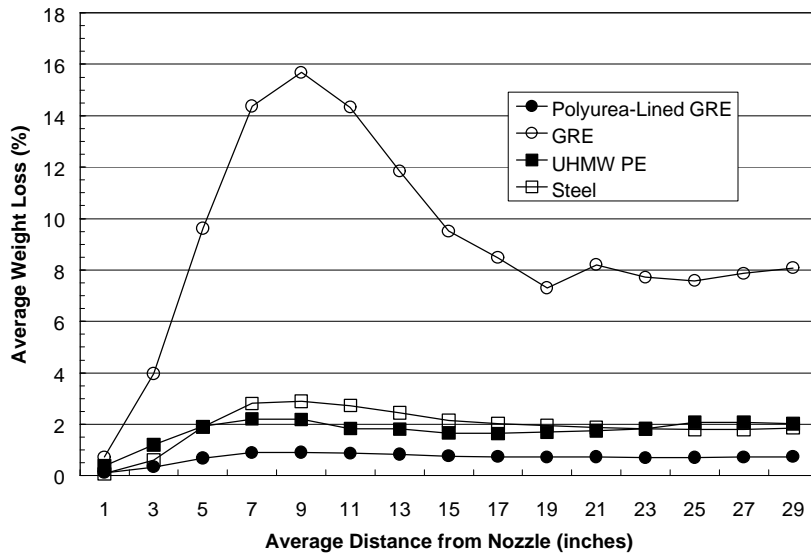
FIGURE 3 - Average weight loss along the length of the pipe specimens after 10 minutes of sandblasting.

The polyurea-lined GRE pipe experienced the lowest weight loss and a wall thickness loss similar to steel pipe. The PE pipe produced weight loss similar to steel but a wall thickness loss roughly half way between steel and the unlined GRE pipe. The steel pipe experienced the highest weight loss but the lowest thickness loss. This apparent contradiction is due to the differences in the specific gravity of the materials. Figure 5 shows the volume loss, and resulting thickness loss, calculated using the weight loss and specific gravity, or density, of the materials. This corresponds to the thickness loss shown in Figure 4 since thickness is a unit of volume. Calculating the volume loss from the weight loss and specific gravity produces a more accurate measurement of the loss of material due to the greater sensitivity of the balance than the calipers.

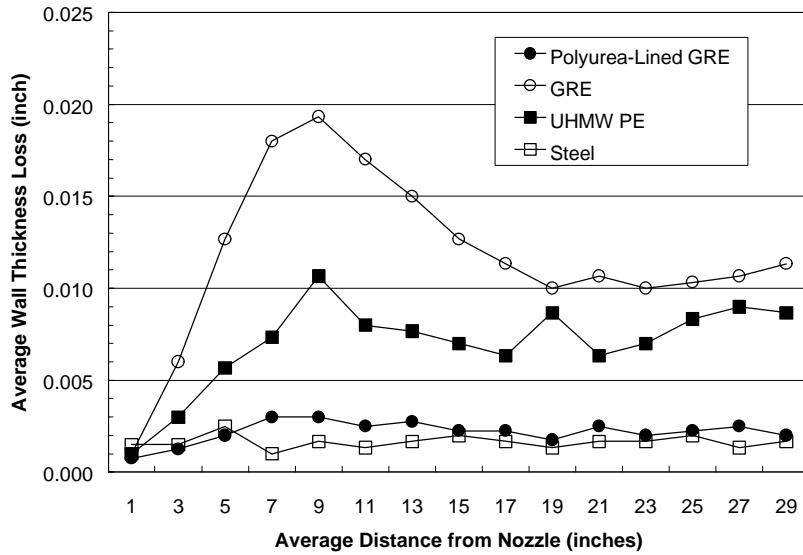
FIGURE 4 - Average wall thickness loss along the length of the pipe specimens after 10 minutes of sandblasting.

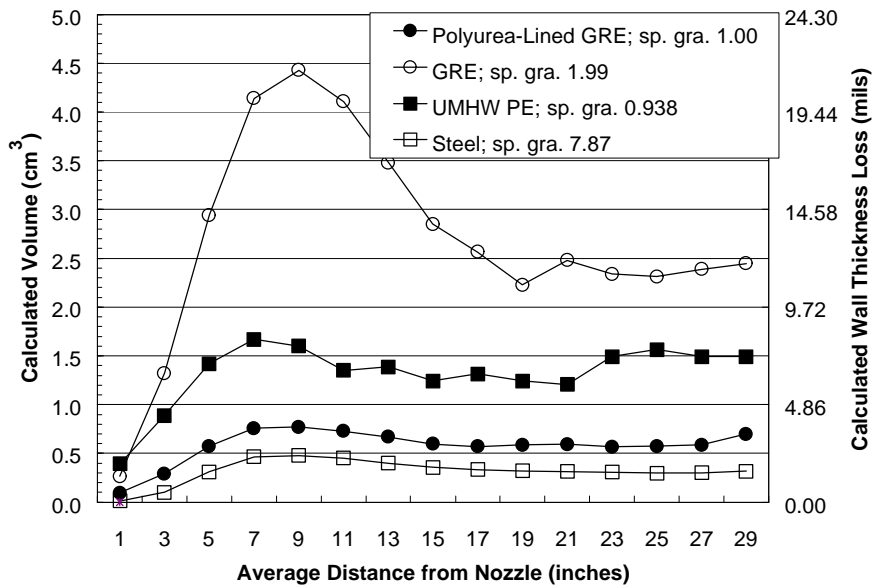
FIGURE 5 - Calculated volume loss and wall thickness loss along the length of the pipe specimens after 10 minutes of sandblasting based on the average weight loss and specific gravity of the materials.

Based on the volume and wall thickness losses, polyurea-lined GRE was almost as abrasion resistant as the steel pipe without the electrochemical corrosion associated with steel pipe.
